Digital jumper cable status report

Noel Stanton Kansas State U. 13 Jan. 2003

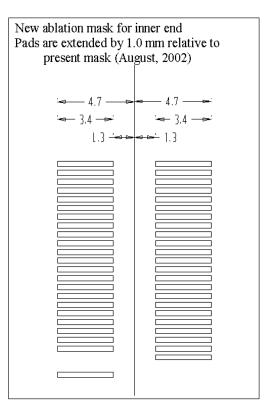
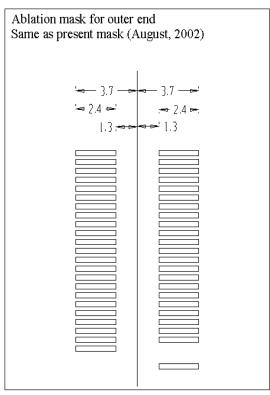
- Plan:
 - 2.5 mm receptacle on hybrid end
 - 3.0 mm plug on outer end
- 2.5 mm footprint too wide for present ablation $(\pm 4.0 \text{ mm from centerline vs} \pm 3.4 \text{ mm})$
- New mask to be made by ALT (inner end only) Will extend 0.5 mm beyond gold pad edge (Present mask ends 0.5 mm inside pad edge)

- 15 Basic 100 cm cables to use this mask Time scale for new mask/ablation ~ 2 weeks
- Mechanical issues (insertion/extraction force; tool) Hans J. has volunteered to investigate
